# Aviation Investigation Preliminary Report

<b>Location:</b>	Kneeland, CA	<b>Accident Number:</b>	WPR24FA252
<b>Date &amp; Time:</b>	July 23, 2024, 11:04 Local	<b>Registration:</b>	N460DC
<b>Aircraft:</b>	TEXTRON AVIATION INC T206H	<b>Injuries:</b>	2 Fatal
<b>Flight Conducted Under:</b>	Part 91: General aviation - Business

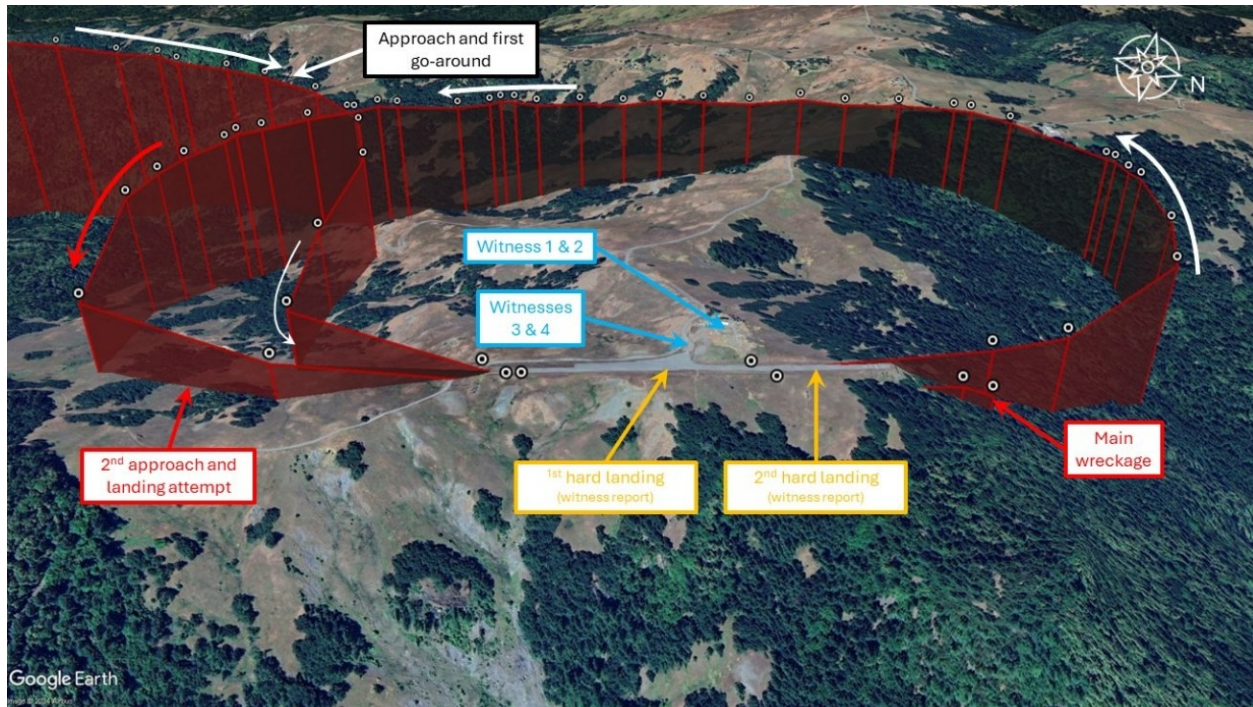
According to the operator, the purpose of the flight was to bring a mechanic and helicopter parts to O19. Preliminary ADS-B data showed that the airplane departed McClellan Park, California about 0949 and then made a left turn to a northerly heading. At 1101, the data showed that the airplane made a turn to the east towards runway 33 followed by a left turn to line up with the runway centerline about 0.4 nautical miles south of the runway threshold. According to witnesses, the airplane overflew the runway at a low altitude and then entered a climb with a subsequent left turn to remain within the airport traffic pattern. The data showed that the airplane flew on the downwind leg at an altitude of about 3,000 ft mean sea level (msl) before it turned base and began to descend. The airplane then started its turn to final slightly east of the runway 33 centerline.

Witnesses reported that they observed the airplane land hard about midfield and bounced. The airplane then landed hard and bounced a second time before it drifted left of the runway centerline and disappeared from their line of sight.

Figure 1: ADS-B flight track data from accident flight with runway contact points

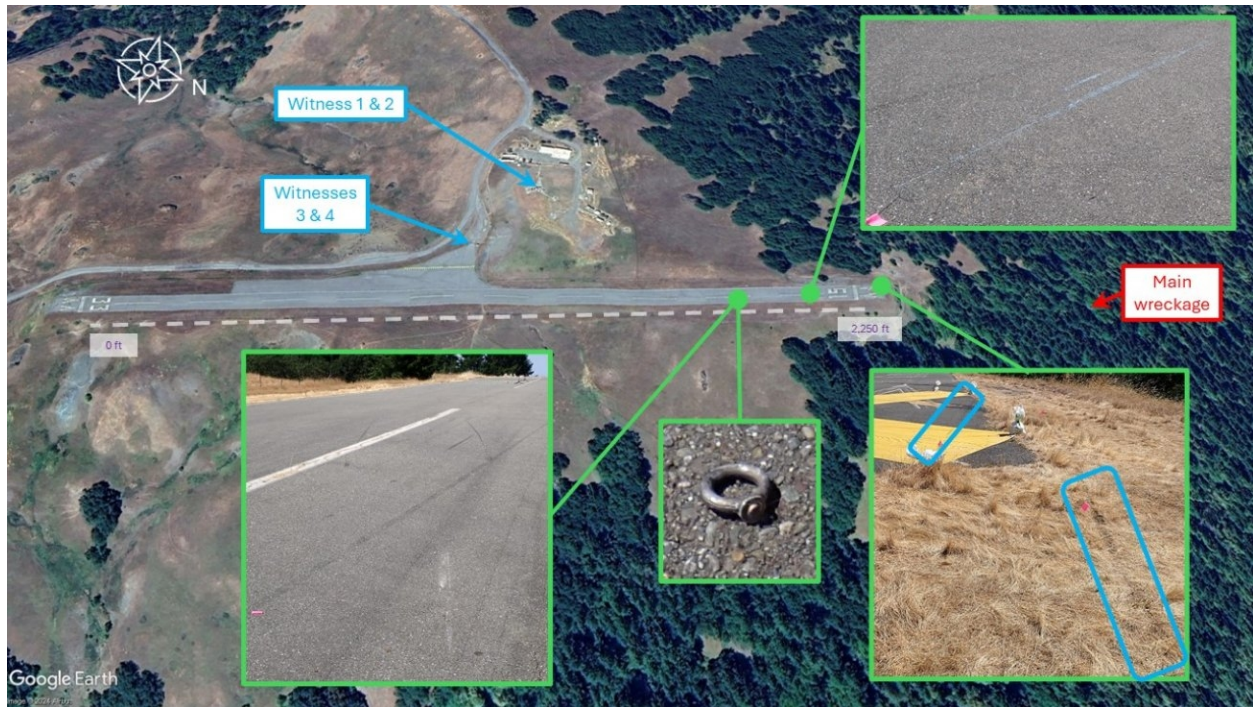
Several ground scars were observed near the departure end of runway 33. A gouge was located on the asphalt surface about 400 ft before the runway departure end, left of the runway centerline with an adjacent scrape mark. A tie down ring was located near the gouge, right of the runway centerline. An examination of runway 33 revealed the presence of tire marks, paint transfer marks, metallic transfer signatures, and additional tire impressions that were all ahead of the tie down ring and on the left side of the runway.

Figure 2: Runway contact signatures
